Kelly Mine: The First Ten Years

Abstract

The following account tells of progress in the restoration of Kelly Mine, a small micaceous hematite mine near Lustleigh in Devon. The restoration, which has been carried out by dedicated members of the Kelly Mine Preservation Society is now in its tenth year and much has been achieved. A short history is provided and various aspects of the original working of the mine as well as the current restoration are discussed. The problems and potential of oral and documented history as a means to authentic restoration are highlighted, as is the value of contemporary photographs.

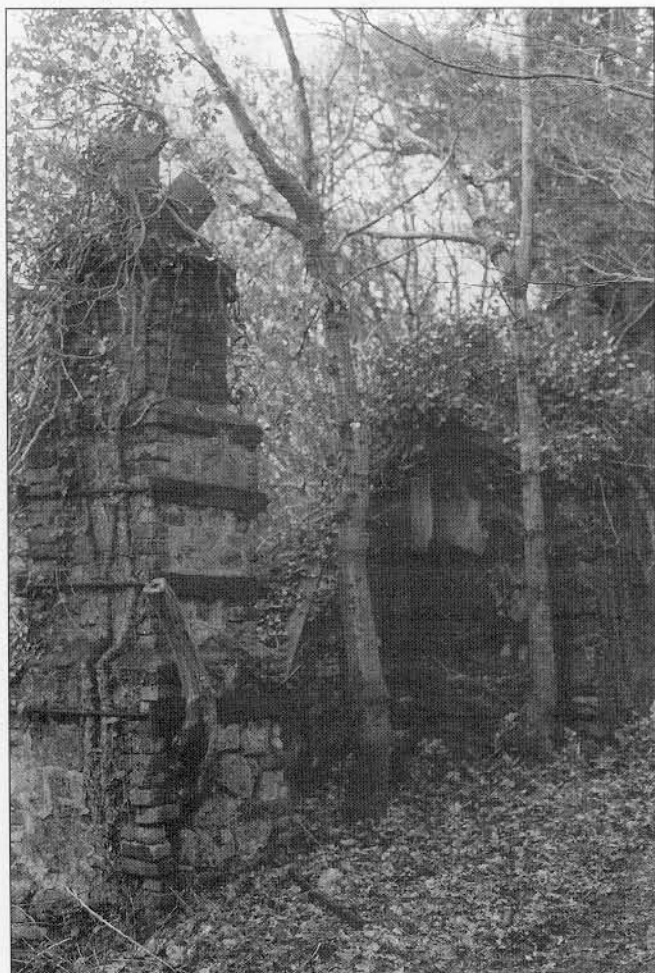
Plate 1. The drying shed in 1986.

An initial examination of the site was not encouraging. All the roofs of the buildings had collapsed, the remaining machinery was left open to the elements and all the tramway track and associated trucks had been removed. Naturally, the wooden leats and most of the water wheel had also rotted away. Beneath the collapsed dressing shed roof the Californian Stamps uprights had rotted, the Blackstone oil engine, the air compressor and the turbine had been stripped of all their attachments and brass bearings. The only building that looked serviceable was the crib hut or miners dry, but on closer inspection that too was seen to require re-roofing and attention paid to the walls.

In 1992 the society entered and gained second place in the National Parks Enterprise scheme which directly led to an application for a grant to roof the drying shed from Dartmoor National Park Authority. The application was successful and the materials were purchased to start this difficult task. The roof of this building had been constructed entirely from wood covered with layers of bitumen to aid heat retention. Work progressed steadily and was completed in early 1995.
