THE WASHING FLOOR AT KILLHOPE LEAD MINE, CO. DURHAM: AN INTERIM REPORT

David Cranstone

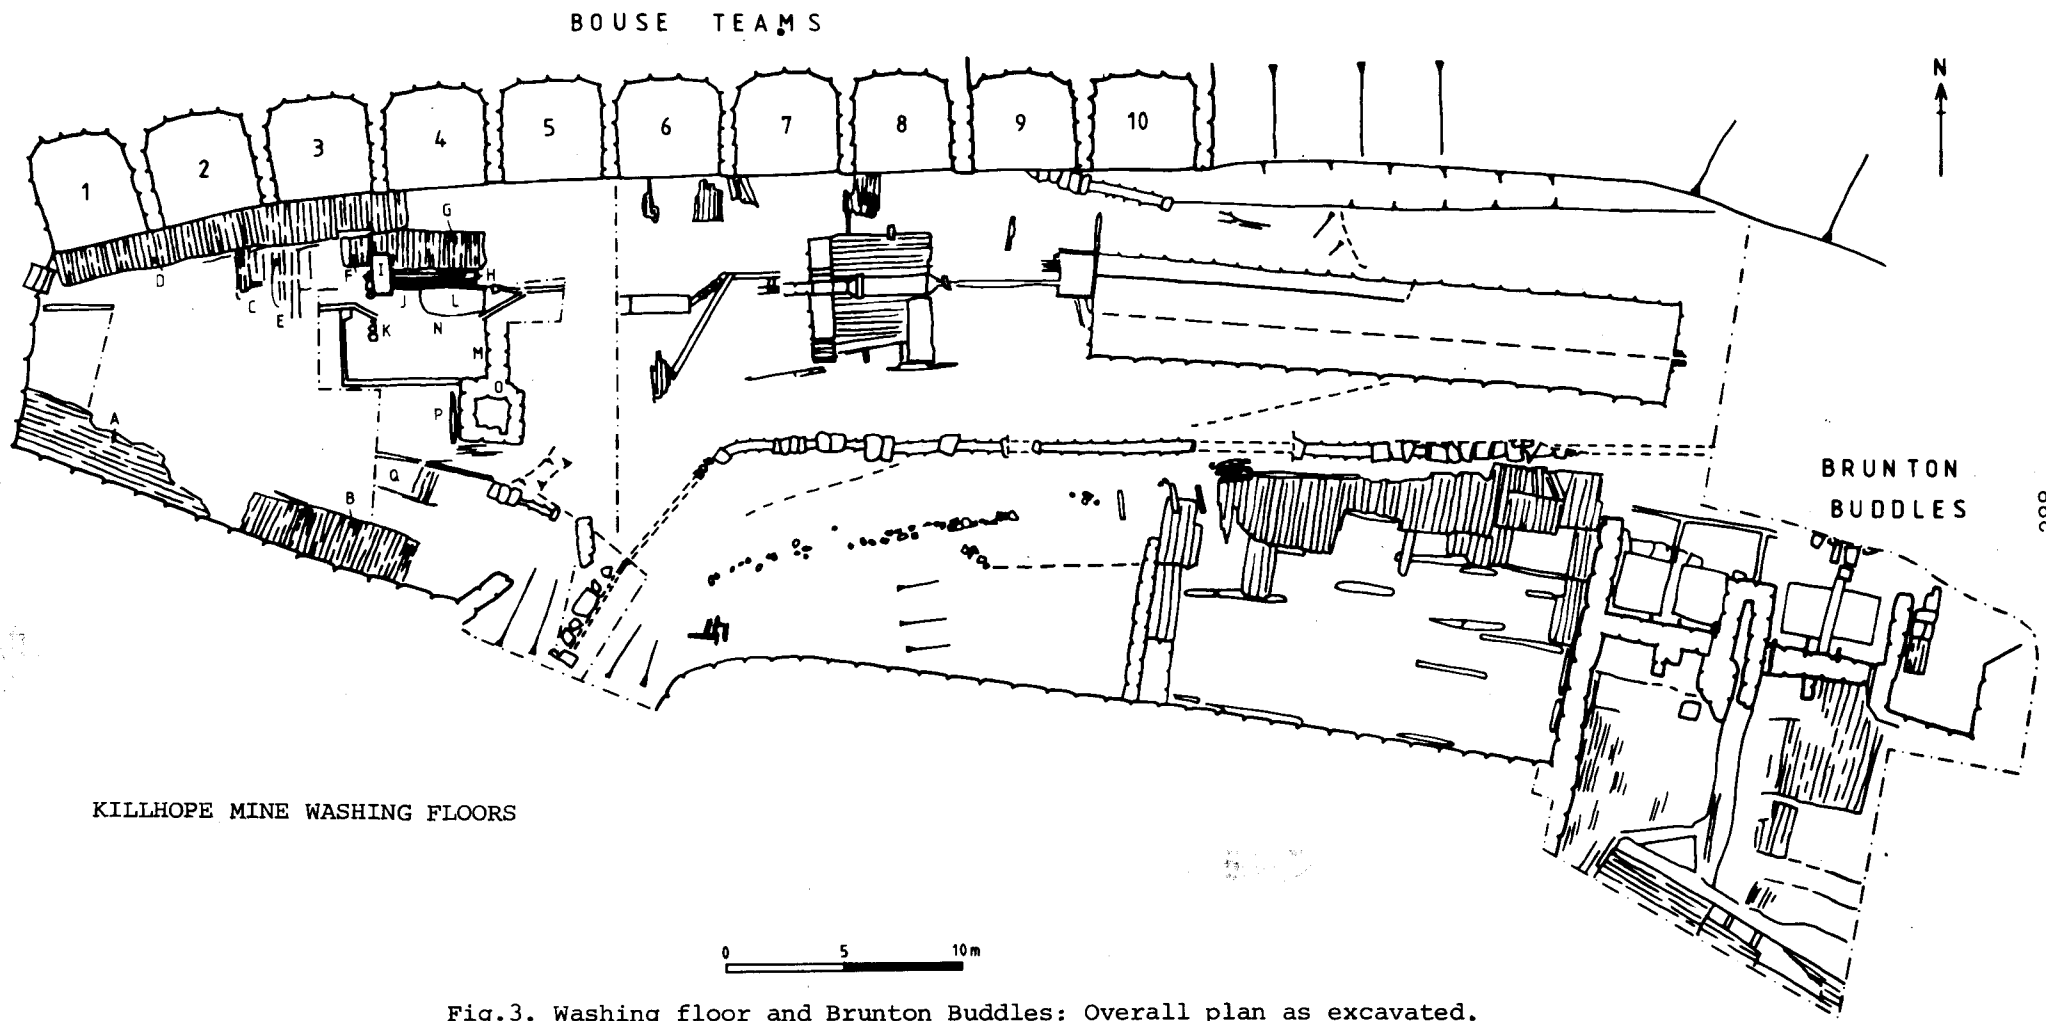
Fig.3. Washing floor and Brunton Buddles: Overall plan as excavated.

To the west of the ramp, the south side of the floor was occupied by two timber platforms, A and B (fig 3). A was of large east-west planks, rather oval in cross-section and lying en echelon; they rested on the hard stony surface to their north. The north and east limits did not survive, though there was evidence to suggest a more complex structure at the east end. Platform B was of north-south beams (probably re-used wooden rails) 0.08m square; it had extended to the ramp, but its east end was fragmentary. Its surface was covered with a pale grey powdery sand, perhaps derived from a water-channel through the revetment wall (5.5m west of the return to the ramp).

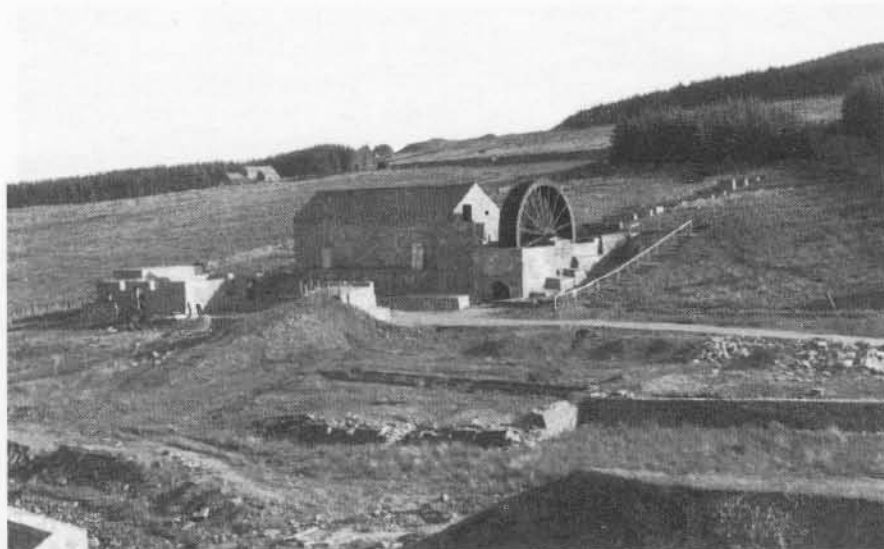
Plate 1. Overall view from the northeast before excavation: bridge abutment in foreground, washing floor and Brunton Buddles in the middle distance, with mechanised dressing mill behind.

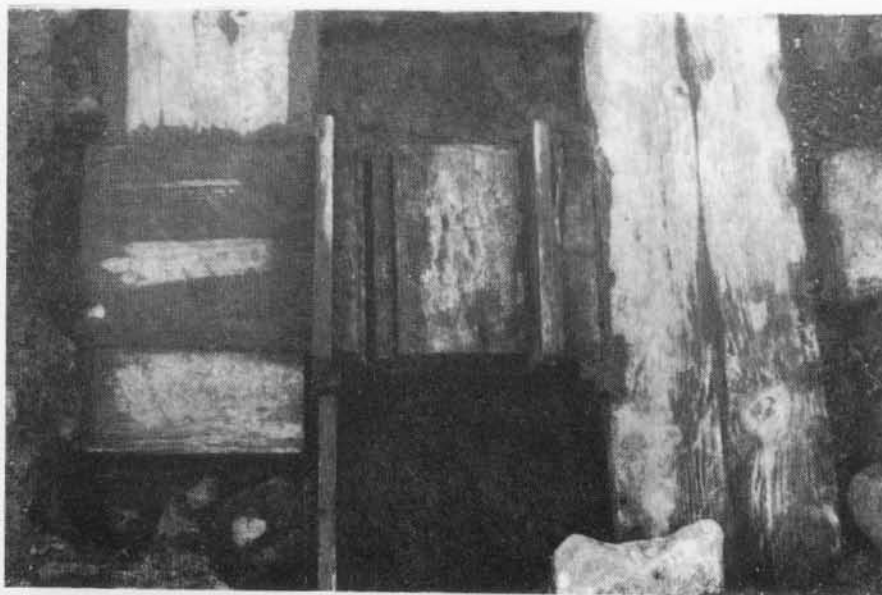
Plate 3. Launders 3 (on right) and 4; riser from launder 4 to AD complex at bottom left, sluice in centre.

continuation of one of the outlets from the area of structure L. Launder 3 flowed ultimately into tank A0, with a fall of 0.14m along its 13.5m observed length. To the south of Launder 3 lay a second launder (4) on an almost-parallel course; the westward origin of this is unknown. Launder 4 ended to the east at a (presumed) riser against the west face of stonework AE; just short of this it had an outlet into launder 3, controlled by a sluice in its roof (the slot for which survived). There was evidence of alteration or repair to this area.

The riser from launder 4 had apparently formed the main water feed to a complex group of structures (AE-AM), referred to overall as AD. The central axis of this group is described first, followed by the structures to either side.(Fig.6).

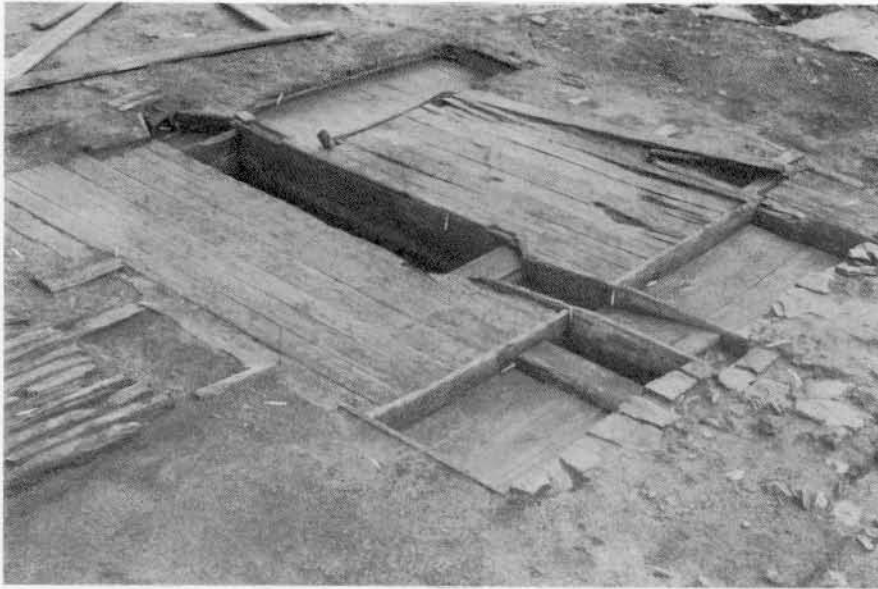
Plate 4. Ore-dressing structures AD from the northeast.

At the west end of the AD group, the water supply from Launder 4 was carried by a riser to a tank or sluice over stonework AE, whence it fed onto a grating over the west end of AF. Bouse was placed on the grating, and raked around in the flow of water; the oversize left on the grating was divided by eye into clean ore and waste (to the bing-stead and dead heaps respectively), and mixed material (to the crusher). This material may have been raked off into pits AH and AI, though wooden platforms are referred to in contemporary descriptions. The undersize was washed down the shoot into the box; when this was full, grating was stopped, and the box re-used as the box of a box-and-trunk (or trunk buddle). The material in the box was agitated with a shovel, so that the fine material was washed over into the trunk (AG), and the coarse material left in the box. This was shovelled out and concentrated in hotching tubs based in pit AL (where the remains of the posts for the lever frames survived; this corresponds with the locations of hotching tubs at Grove Rake). When AG was almost filled with fines, these were shovelled out and re-processed in the same tank (now used as a trunk buddle), shovel-fulls being placed on the headboard and stirred in a gentle flow of water to wash away the waste and leave the ore on the board.

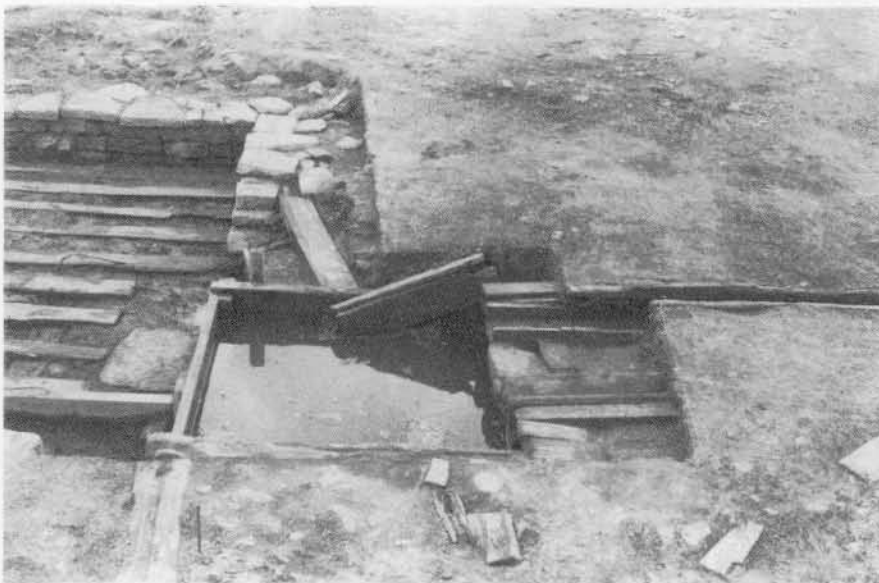
Plate 5. Tank AO from the north; settling tanks to the left.

The outlet water from all the ore-dressing structures on the washing floor was carried by launders to tank A0, at the northwest corner of the settling tanks (the probable exception is AL, whose outlet water may have flowed directly to the settling tanks). This tank measured 1.76 m x 1.52 m and was 0.95 m deep from the ground surface to its north; the (damaged) west half of the south side had also probably extended to ground level, whereas the remaining sides were only 0.7 m high. The tank was walled and floored with planks, retained with pegs and battens. Launders 3, 5, 6, and 7 fed into the tank over the top of the west wall, their sides being supported in places with slabs. Water had presumably flowed over the east wall into the northern and central divisions of the settling tanks (there were no surviving traces of the sluices that would be expected, though slabs in the floors of the settling tanks suggested the locations of the inlets). A damaged timber structure (AP) running south-southeast from the south side is interpreted as the remains of a feed to the southern division of the settling tanks. Tank A0 had been infilled before the settling tanks.

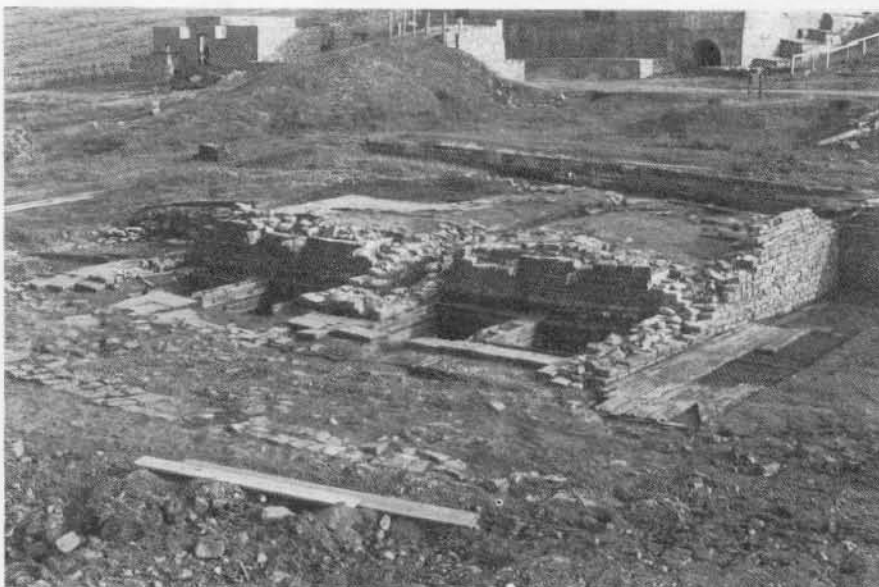
Plate 6. Brunton Buddles as excavated from the northwest.

The Brunton Buddles themselves had lain immediately to the north of the Platform; a set of four had been present, divided into two pairs by a central wheelpit which had powered them. This wheelpit projected through the north wall of the platform, and was 2.9 m long and 0.5 m wide. The water inlet had been by an iron pipe (see above) only 0.6 m above the base; this had probably syphoned up to feed the top of an overshot or pitchback wheel. The tailrace was only 0.5 m wide and 0.2 m high and fed into a smaller launder. The wheelpit was of one build with the Platform to its west, but was abutted by the Platform to its east, indicating that the eastern two Brunton Buddles were an addition - this was confirmed by various slight differences in construction.

The Brunton Buddle consisted of an endless loop of conveyor belt, onto the upper surface of which was fed a 'pulp' of fine sediment, and a flow of fresh water. Galena particles collected on the belt and were carried over the top of the loop, whereas waste was washed off down the belt. The 'heads' were recovered by passing the belt through a cistern of fresh water, from which they were shovelled at intervals. Four belts had been present at Killhope, the upper ends being held by eight beams projecting from the north face of the Platform wall. Beneath each pair of beams lay a collecting cistern, consisting of a solidly-built timber tank 0.6 m deep. A length of conveyor belt survived in one of these tanks. The tanks were divided into two pairs by the wheelpit; the overflows from each pair had passed into a small box at the north end of the space between the tanks, and thence via small launders into an outlet launder along the north edge of the excavation (which also carried the tail water from the wheelpit). The spaces round the tanks had been planked, whereas the area to the north had been flagged.

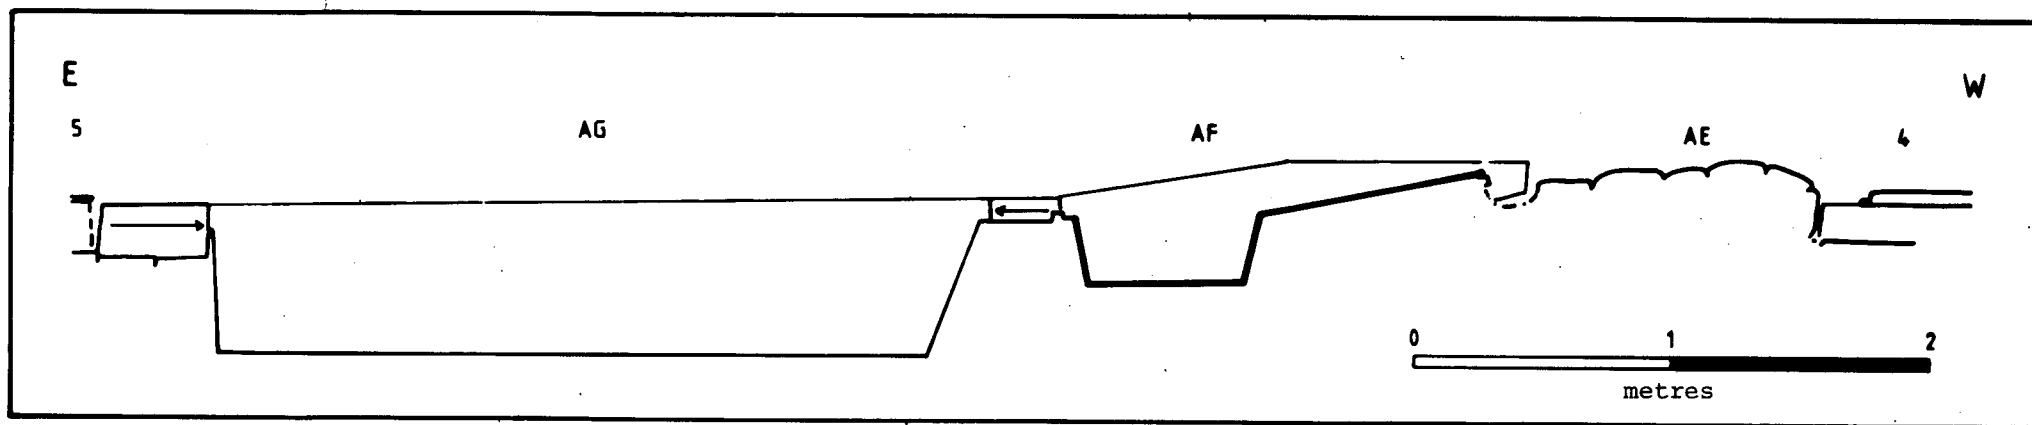
Fig.6. Profile along the axis of the AD group.
Projected side walls of structures in thin line;
iron plates in AF in heavy line.

The west end of the axis was formed by a rectangular area of sandstone masonry (AE), faced to the east only, and covered with sandy clay (perhaps the bedding for a superstructure). The east side was adjoined by the side-walls of structure AF, though the floor of AF was separated by a gap of 0.2 m, filled with clay. AF consisted of two parts, a shoot feeding eastwards into a box. The shoot was 0.4 m wide and 0.86 m long, with a fall of 0.15 m along its length; its east end was 0.26 m above the floor of the box. The box was 0.66 m long at the top, and 0.56 m at the base, the end walls being inclined at 20° to the vertical. The side-walls of the whole structure were of single stout edge-laid planks; they were flat-topped to the west, but sloped eastwards from a point 0.2 m short of the west end of the box. There was a wear-mark above the junction of the shoot and the box, and the tops contained nailholes from here eastwards. The floor of the shoot, and the floor and all walls of the box, were plated with iron, the shoot having been patched.

The remainder of the axis was occupied by a rectangular tank (AG), with shallower triangular extensions at each end. The west end consisted of a flat-floored channel widening to the east, with a narrow cross-batten at the junction with AF (above which the adjacent platforms were heavily worn). The floor was 0.1 m below platform level, and 0.24 m above the floor of the box of AF. The main tank was 0.8 m wide and 0.6 m deep from platform level, with a precisely-flat floor. The west wall sloped at 20° to the vertical, and the east wall at 3° . The basal infill consisted of 0.1 m of hard galeniferous sand, with a single large plank laid along its centre. The triangular east end had a rather poorly-laid floor, 0.2 m below platform level, and separated from the main tank by a 0.1 m lip. It fed into an outlet launder (5) flowing into tank A0, with a fall of 0.05 m over its 5 m length. While the walls and floor were of normal solid construction, the roof was of loose offcuts and pieces of wood, at surface level.
