ARBOR LOW CALCITE MINE, YOULGREAVE, DERBYSHIRE

R.P. Shaw

Abstract: This account follows that on the adjacent Long Rake Spar Mine (Shaw, 1995) and outlines the history of the mining of calcite, also known as spar, Derbyshire Spar, Calcspars, at Arbor Low Mine, the other larger calcite producer on Long Rake. Brief additional notes on Long Rake are appended.

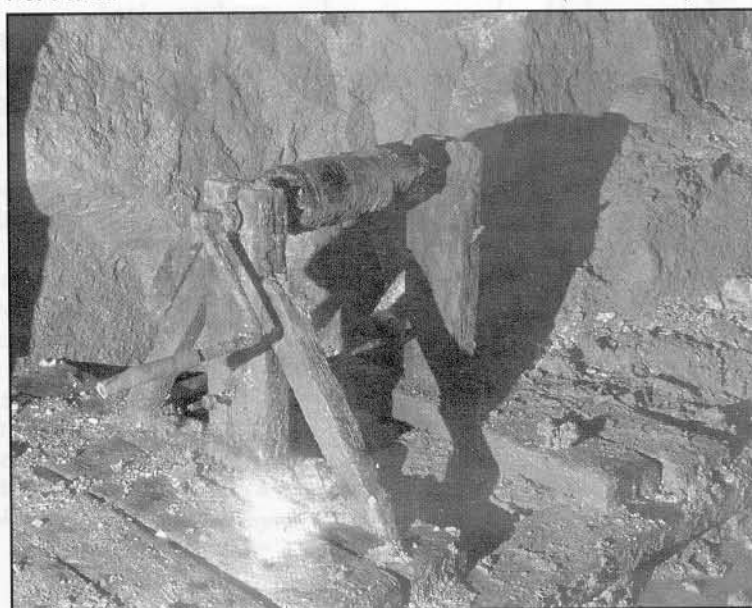
Plate 3. Wooden stoves on a small internal shaft on the north side of the No. 1 level. (Photos RPS).

The ladderway upwards gave access to the No. 1 level and onwards to the surface. At this level (No. 1), before further progress to the west was prevented by the tailing slurry, there was an old timber stowes on a small shaft.

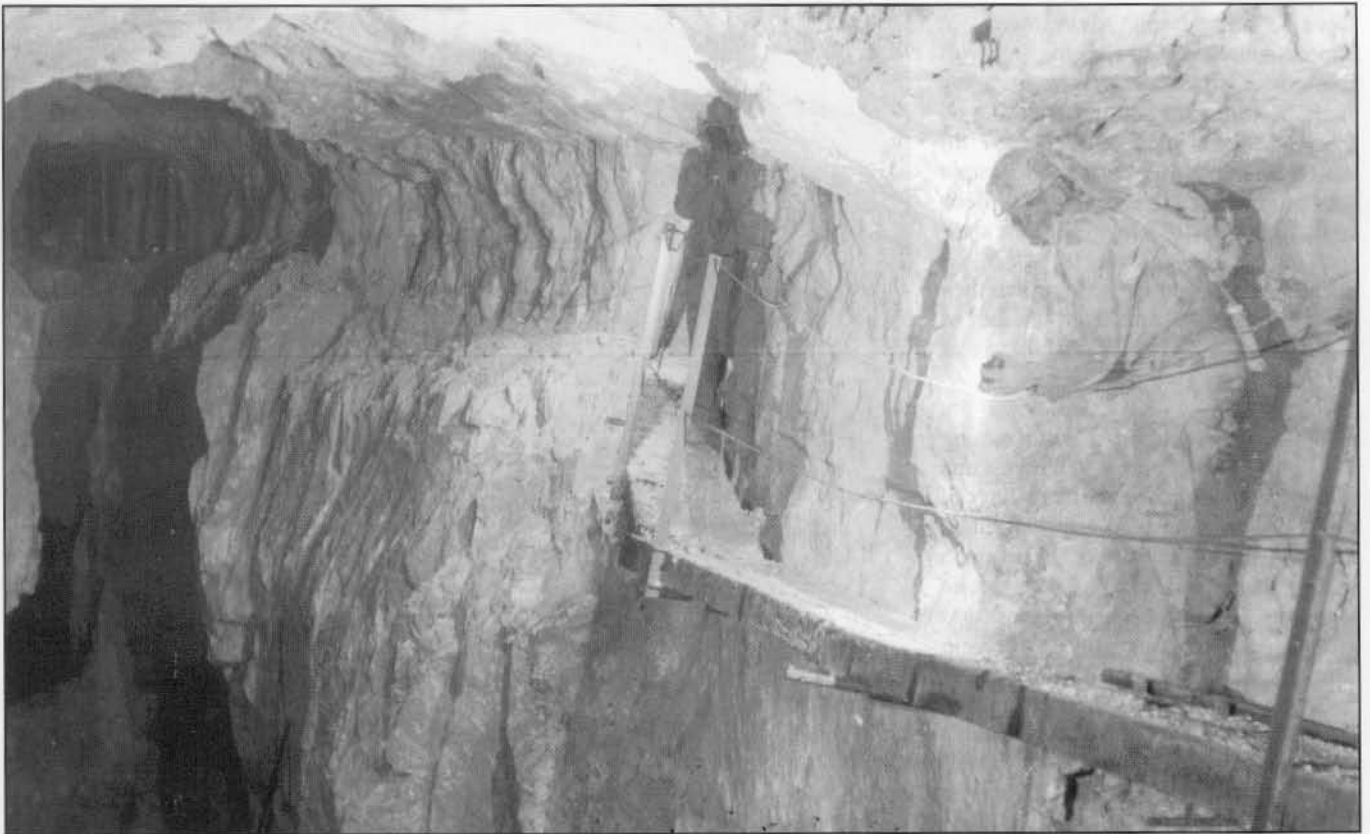
Plate 4. Railway sleepers and rock-cut ledge "catwalk" at the western end of the No. 2 level.

Manways to the emergency exits were made by making catwalks from paired railway sleepers supported on drill-steels projecting from shotholes drilled into the walls. "Handrails" of old wire winding rope supported on angle iron bars were provided. The condition of some of the cat walks, by now over 20 years ago, was suspect! Around some of the gaps in the floor ledges were left or cut to serve the same purpose as the sleeper catwalks.
